LAKE HARBOR PARK
MONA LAKE CHANNEL ENTRANCE
SHORELINE REVETMENT

MAY 1986

Prepared For: City of Norton Shores 4814 Henry Street Norton Shores, MI 49441

Prepared By:
JOHNSON & ANDERSON, INC.
4479 Dixie Highway
Drayton Plains, MI 48020

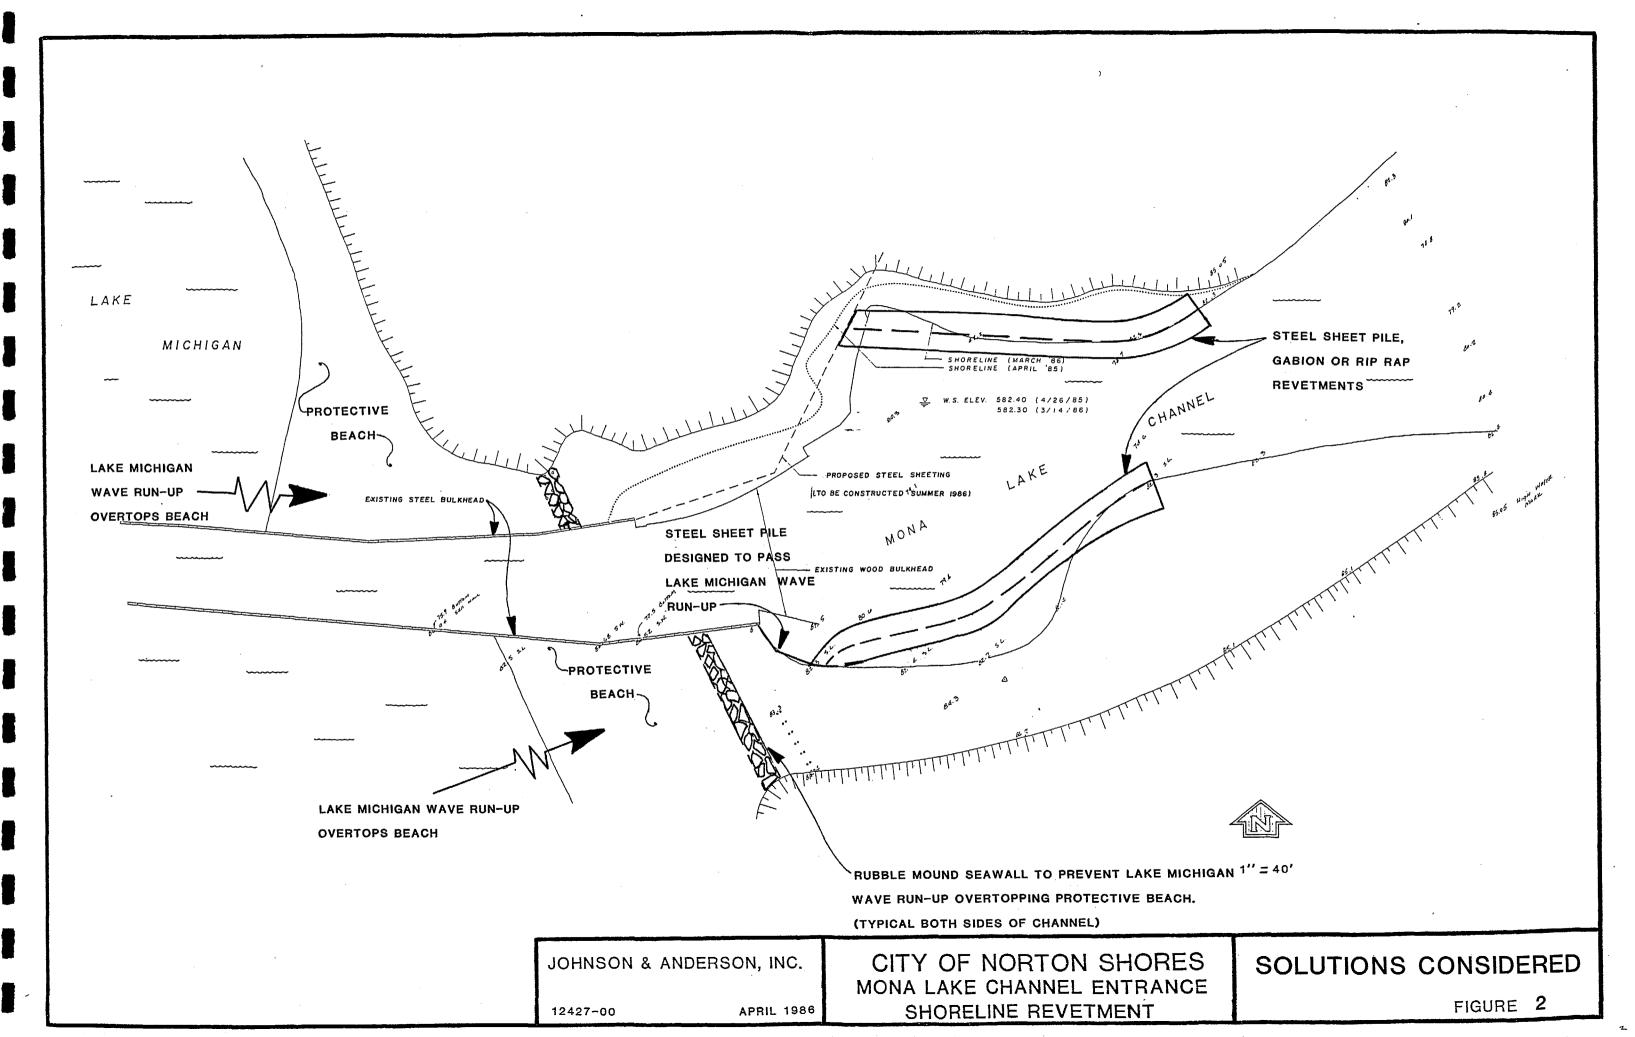
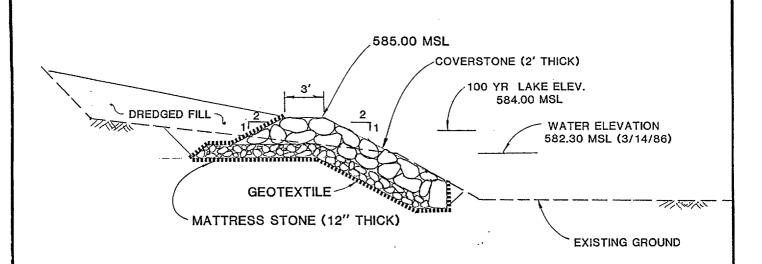
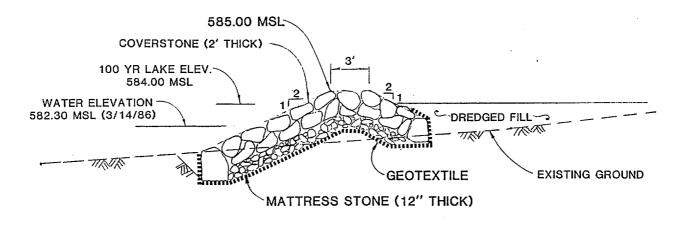
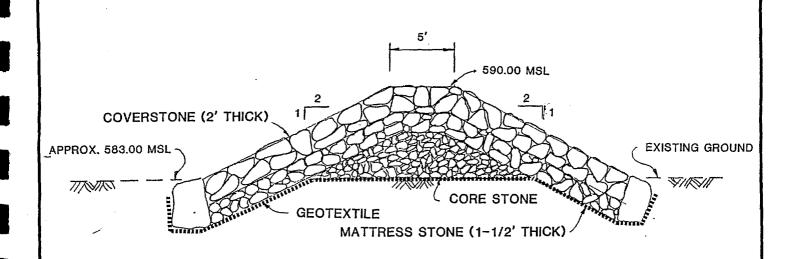
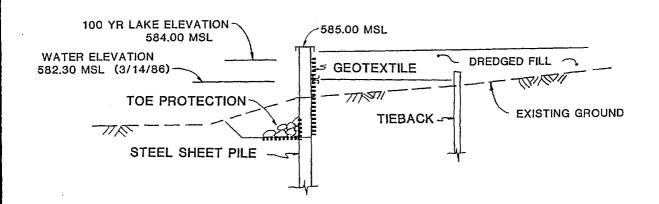
# RIP RAP REVETMENT

**NORTH BANK**

# **RIP RAP REVETMENT**

SOUTH BANK

# RUBBLE MOUND SEAWALL

# STEEL SHEET PILE BULKHEAD

Pervious, rough, inclined, surfaces such as rip rap and stone are good ways to dissipate wave energy in the "basin" area. Waves impacting such surfaces will be trapped in the rough, open spaces in the surface, thereby dissipating wave energy. The "basin" area should be protected by rip rap or stone on one or both shores to dissipate the energy of waves from boat wakes, reflected waves, and wind generated waves travelling straight up the channel. Possible solutions include rip rap revetments and stone filled gabion revetments for the basin area. Rip rap is a layer or facing of randomly placed stones to protect the shore from erosion. See Figure 3 for sketches of rip rap revetments.
